**FORENSIC ENGINEERING STUDY OF DAMAGES TO
RESIDENCE OF JOHN & HELEN POLITZ AT
116 WINTERS LANE, LONG BEACH, MS.**

FROM HURRICANE KATRINA

JULY 14, 2008

**TED L. BIDDY, P.E., P.L.S.
7059 BLUEBERRY HILL DRIVE
TALLAHASSEE, FL 32303
850-536-0928
TedBiddy@msn.com**

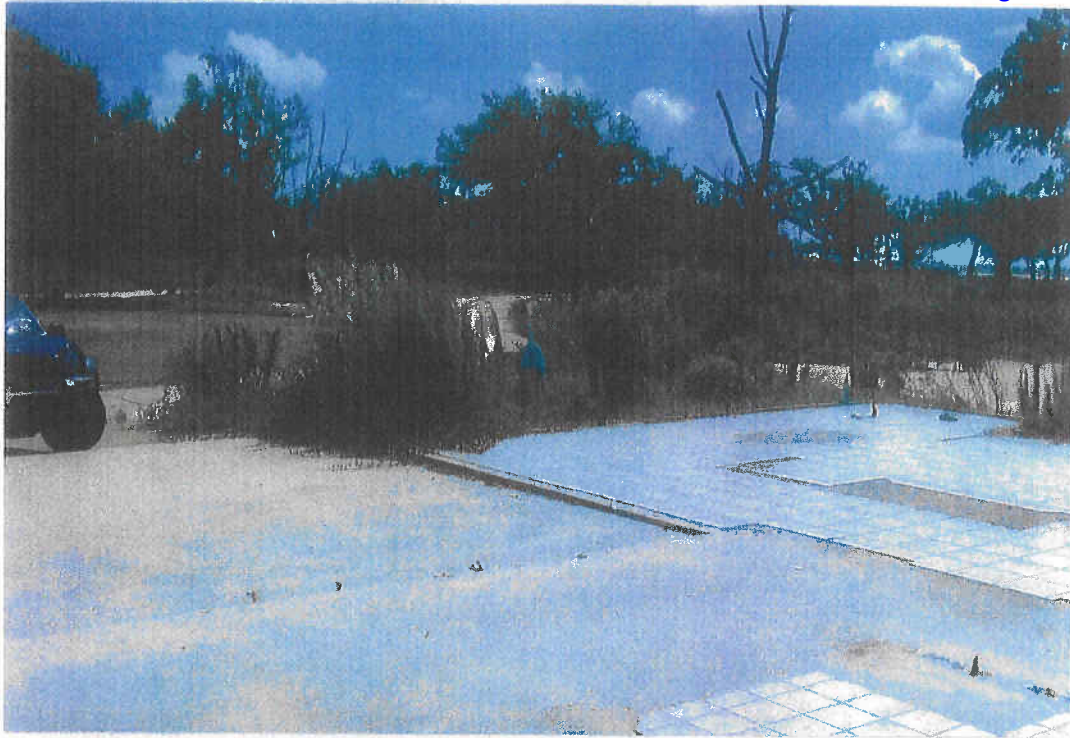
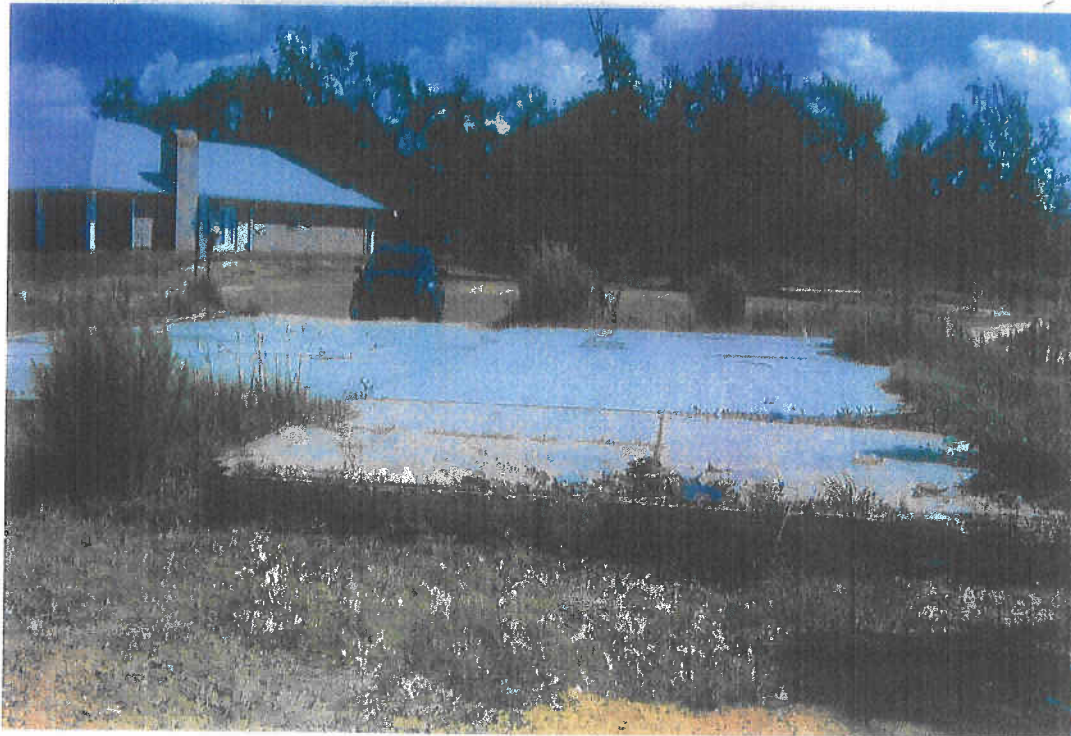
VIEWS OF REMAINING CONCRETE SLAB FOUNDATIONS

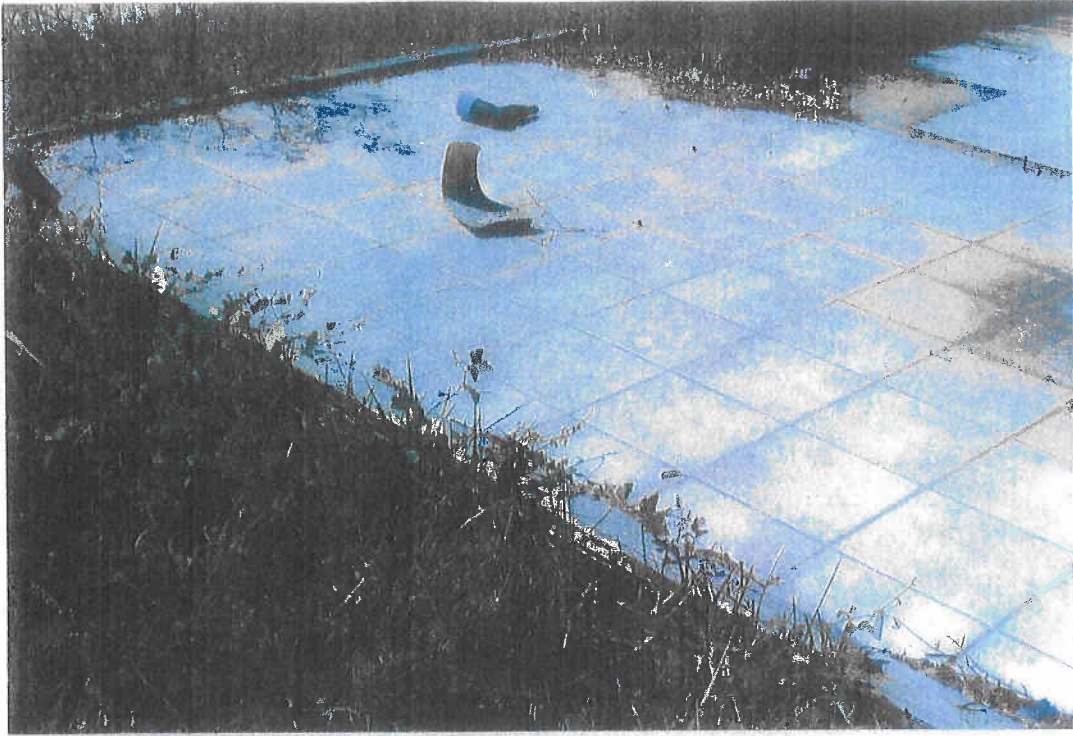
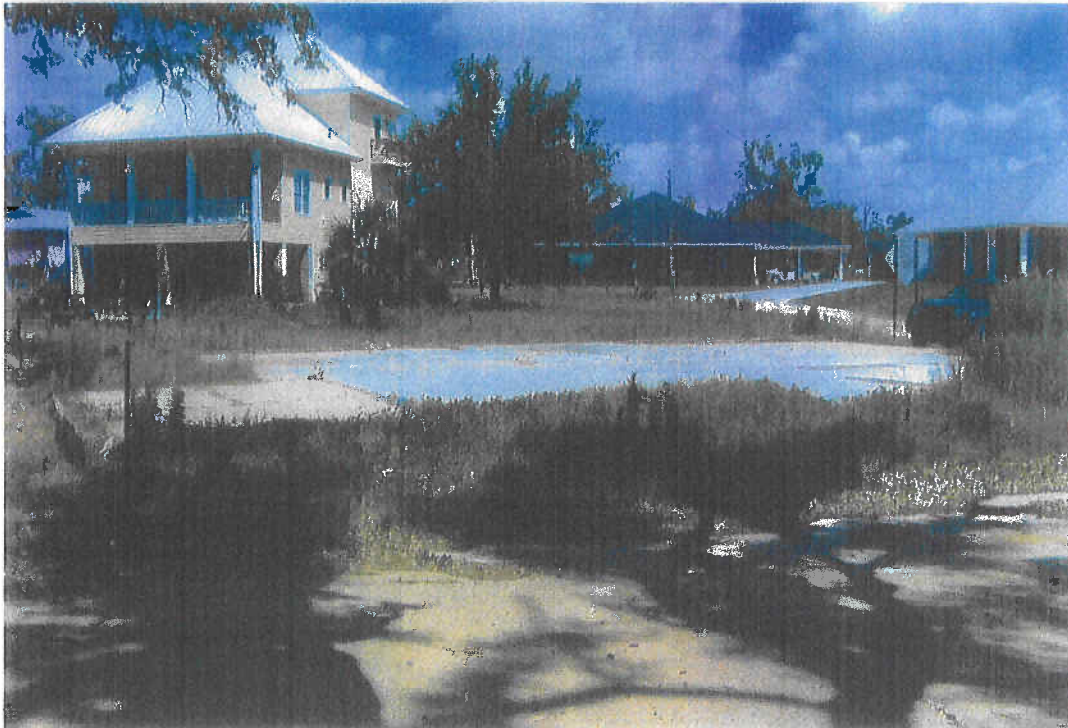
VIEWS OF REMAINING CONCRETE SLAB FOUNDATIONS

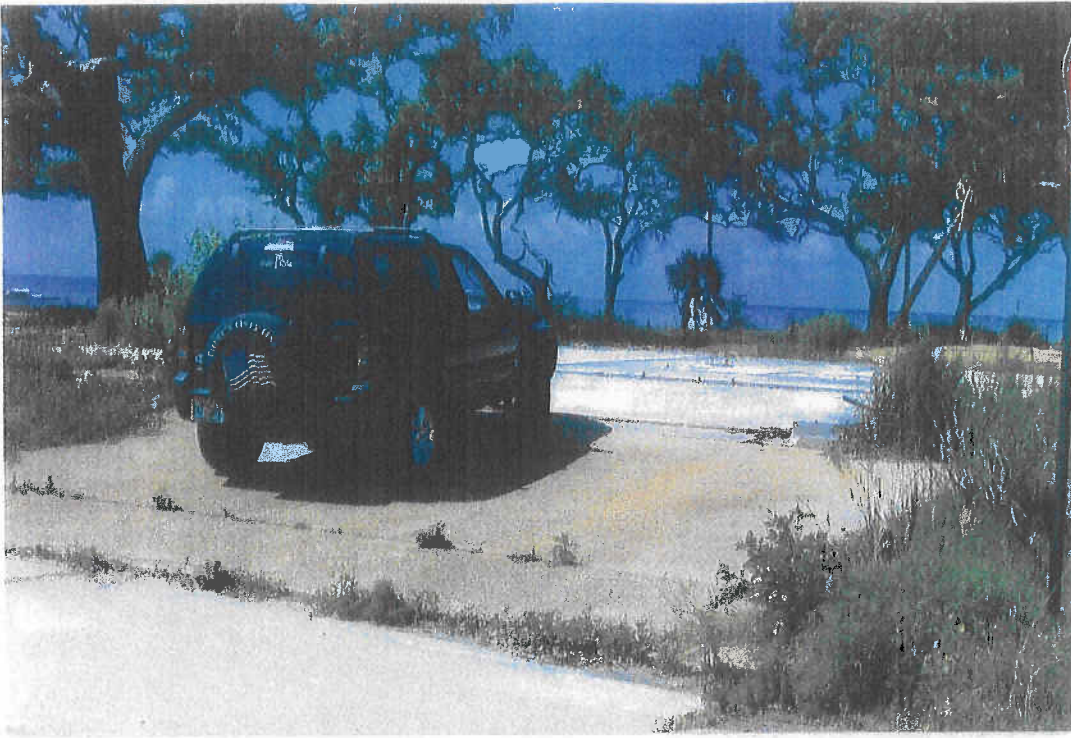
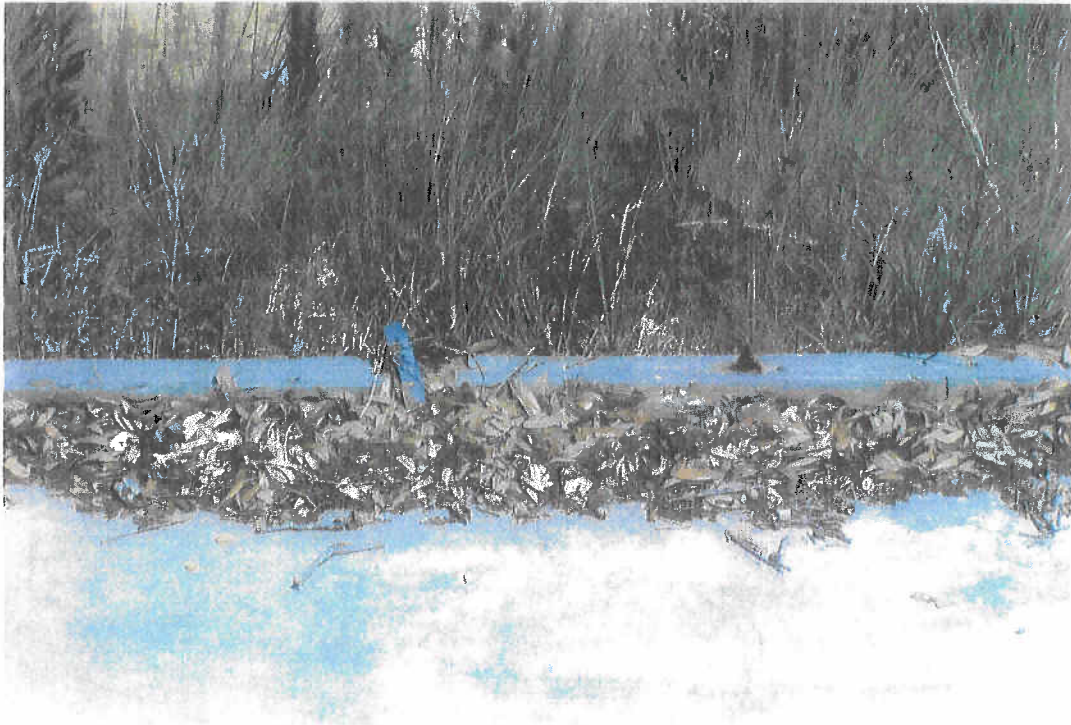
VIEWS OF REMAINING CONCRETE SLAB FOUNDATIONS

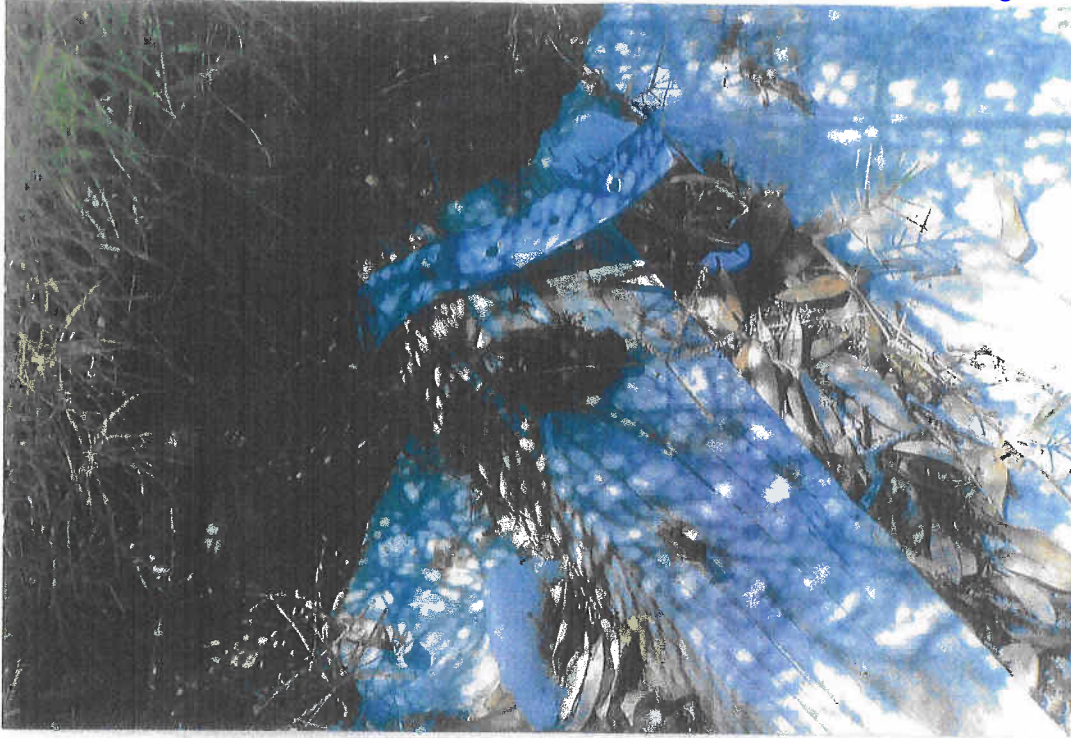
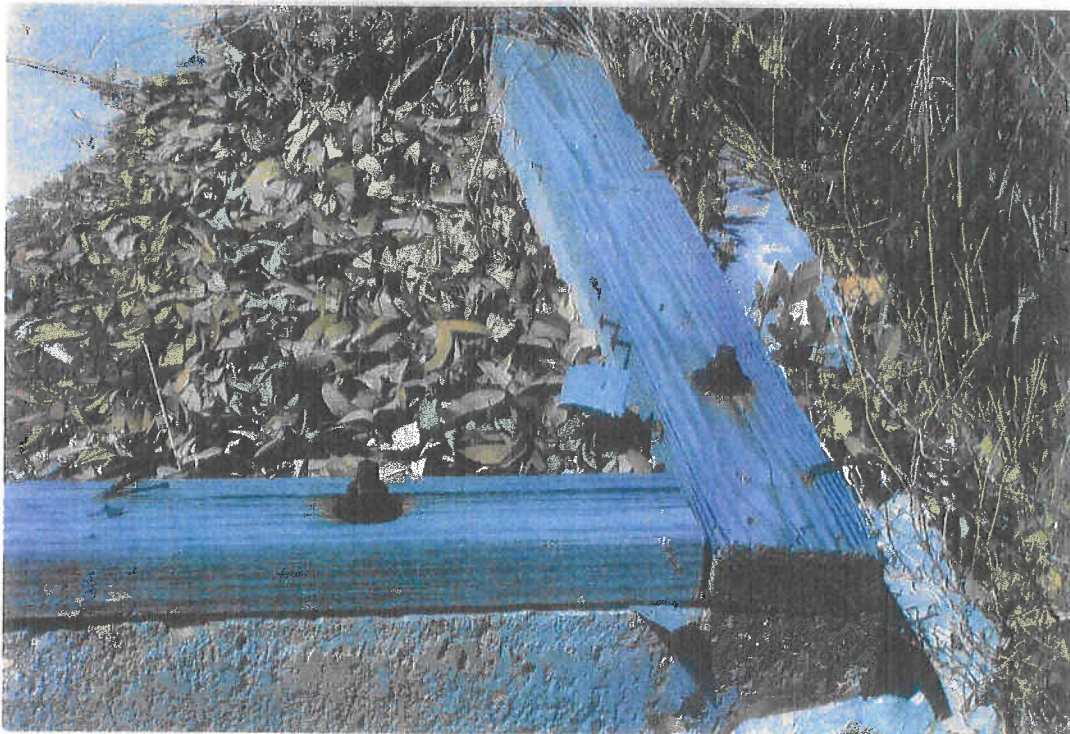
Since we know, based upon my inspection, that the wall studs failed by pullout from their nailed connections to bottom base plates, and nail pullouts from metal straps, and metal strap failures through breakage, it is certain that the nailed on wall studs failed at their bottom connections. It is therefore an engineering certainty that the wall studs to bottom base plates could not withstand the forces from the 135 MPH winds of the storm.

**VIEWS OF REMAINING BASE PLATES, NAILED CONNECTIONS,
BROKEN METAL STRAPS, AND ANCHOR BOLTS ON
CONCRETE SLAB FOUNDATIONS**

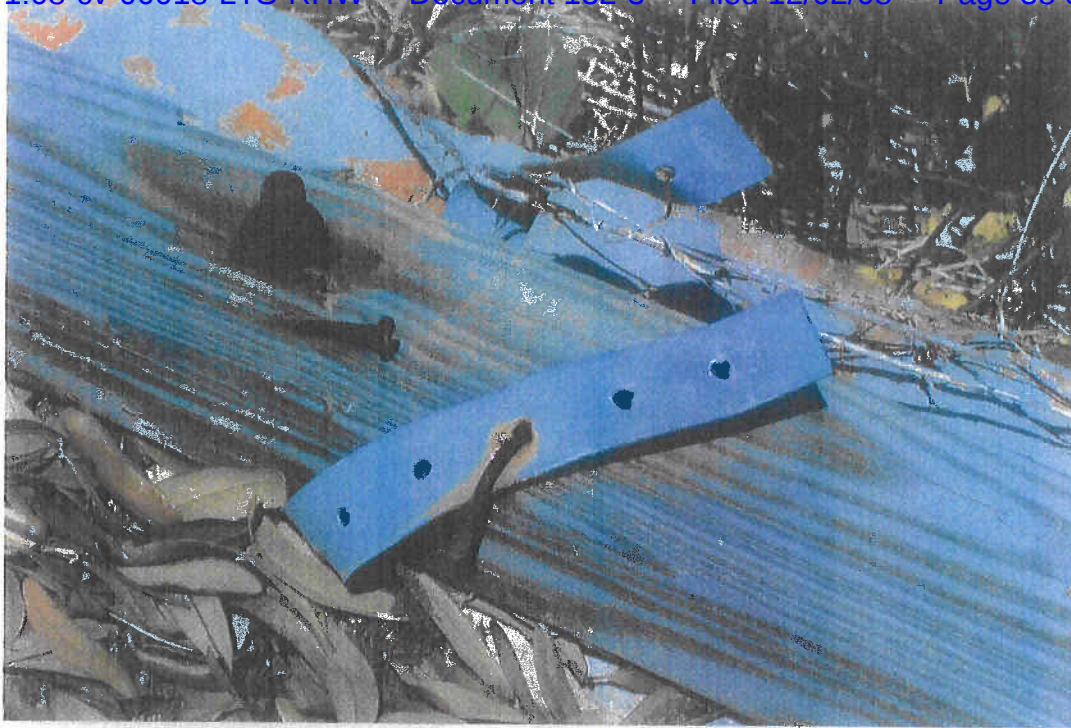
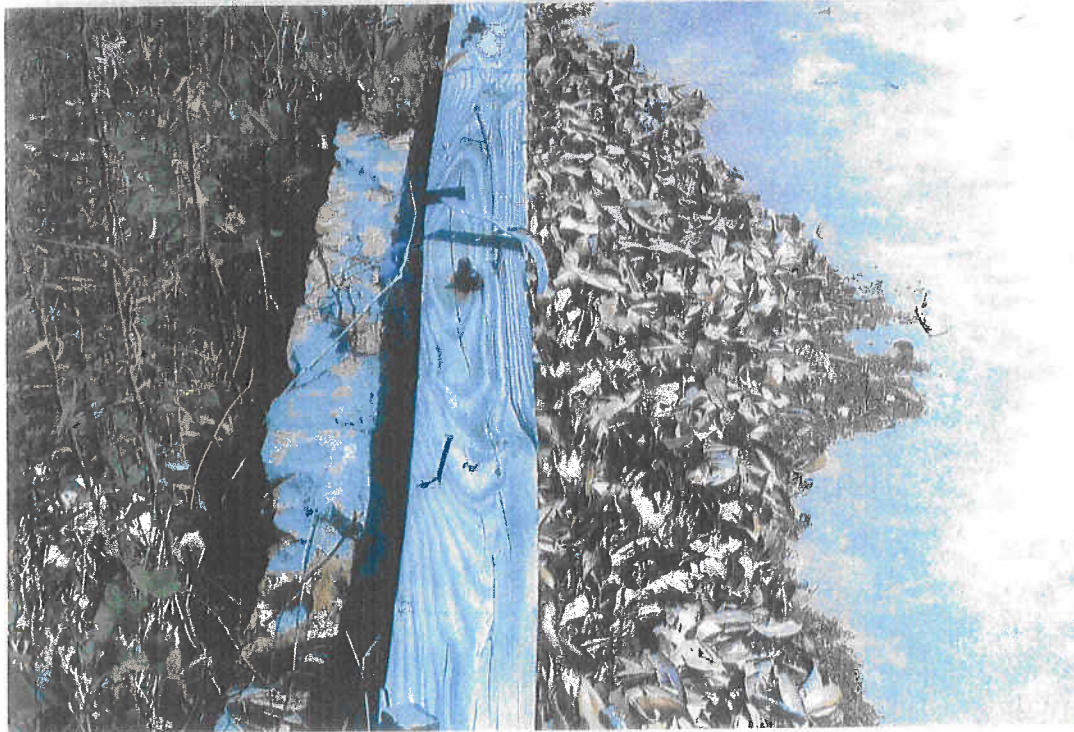
**VIEWS OF REMAINING BASE PLATES, NAILED CONNECTIONS,
BROKEN METAL STRAPS, AND ANCHOR BOLTS ON
CONCRETE SLAB FOUNDATIONS**

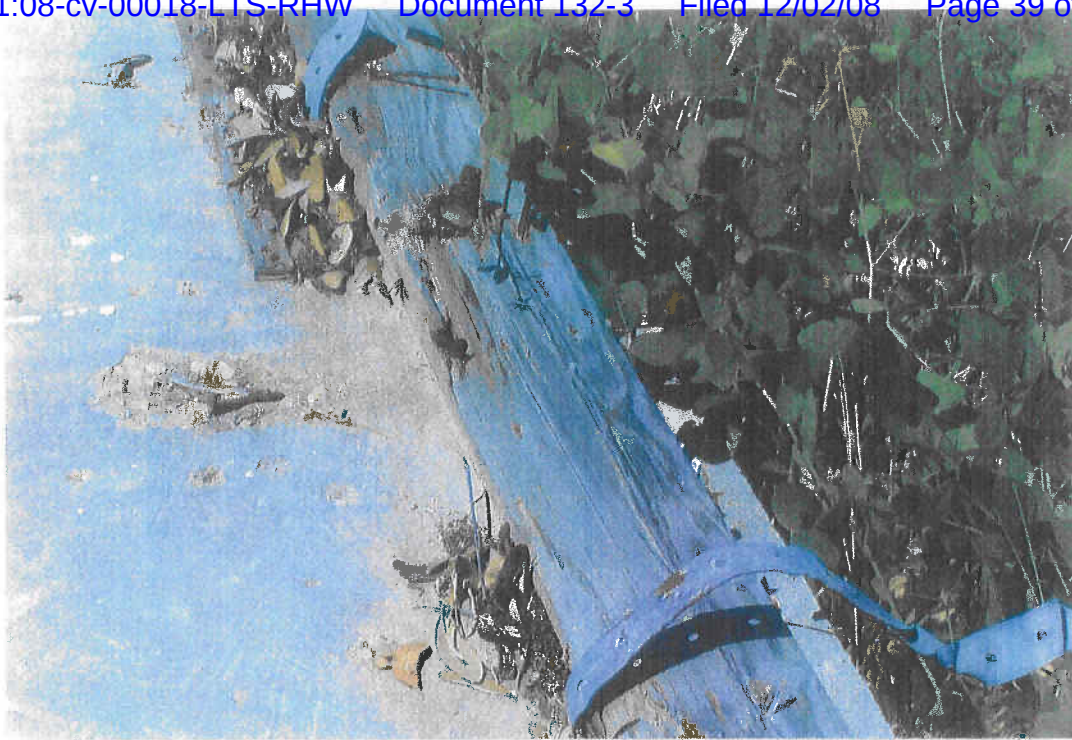
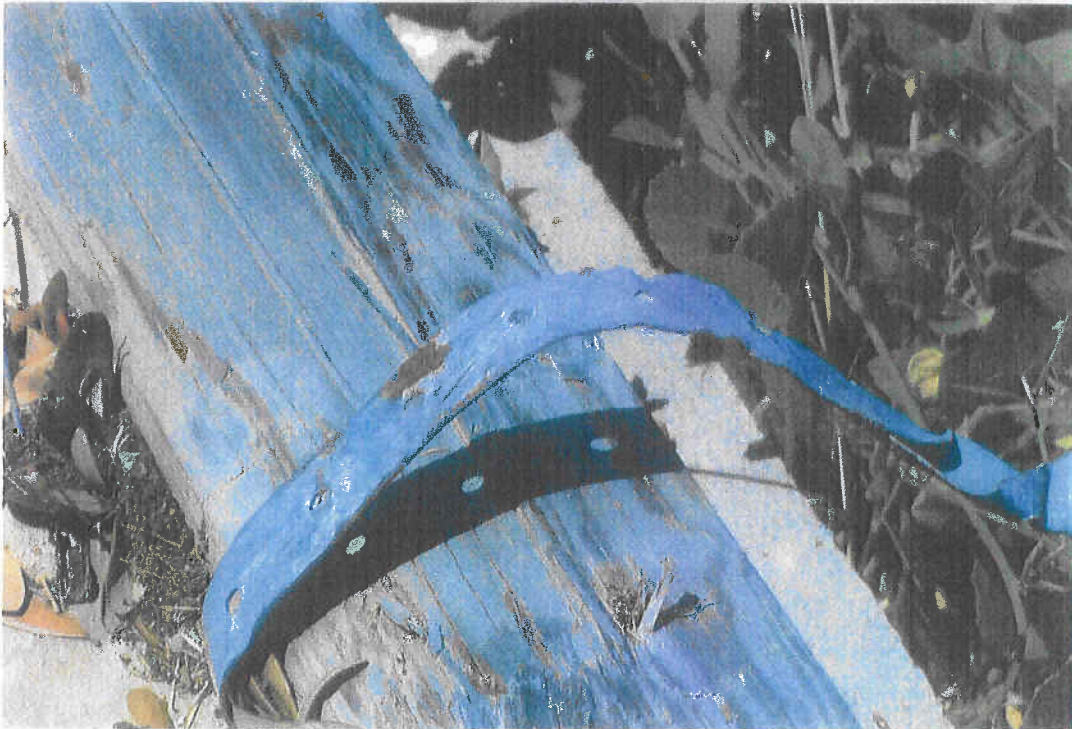
**VIEWS OF REMAINING BASE PLATES, NAILED CONNECTIONS,
BROKEN METAL STRAPS, AND ANCHOR BOLTS ON
CONCRETE SLAB FOUNDATIONS**

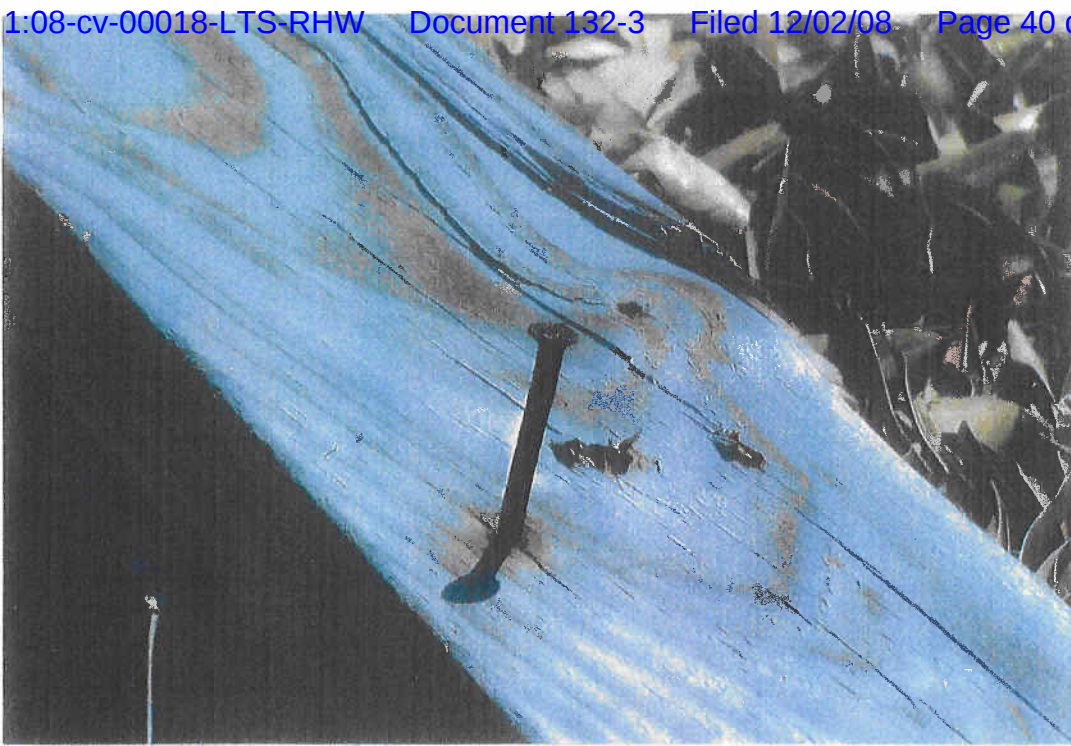
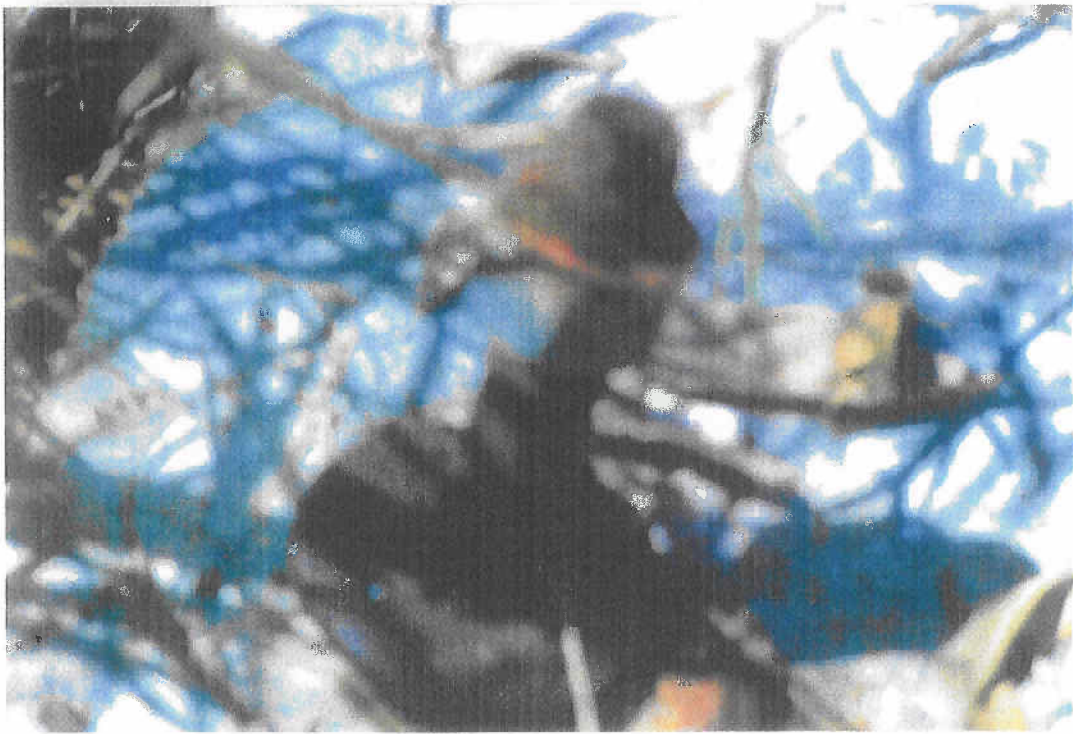
**VIEWS OF REMAINING BASE PLATES, NAILED CONNECTIONS,
AND ANCHOR BOLTS ON CONCRETE SLAB FOUNDATIONS**

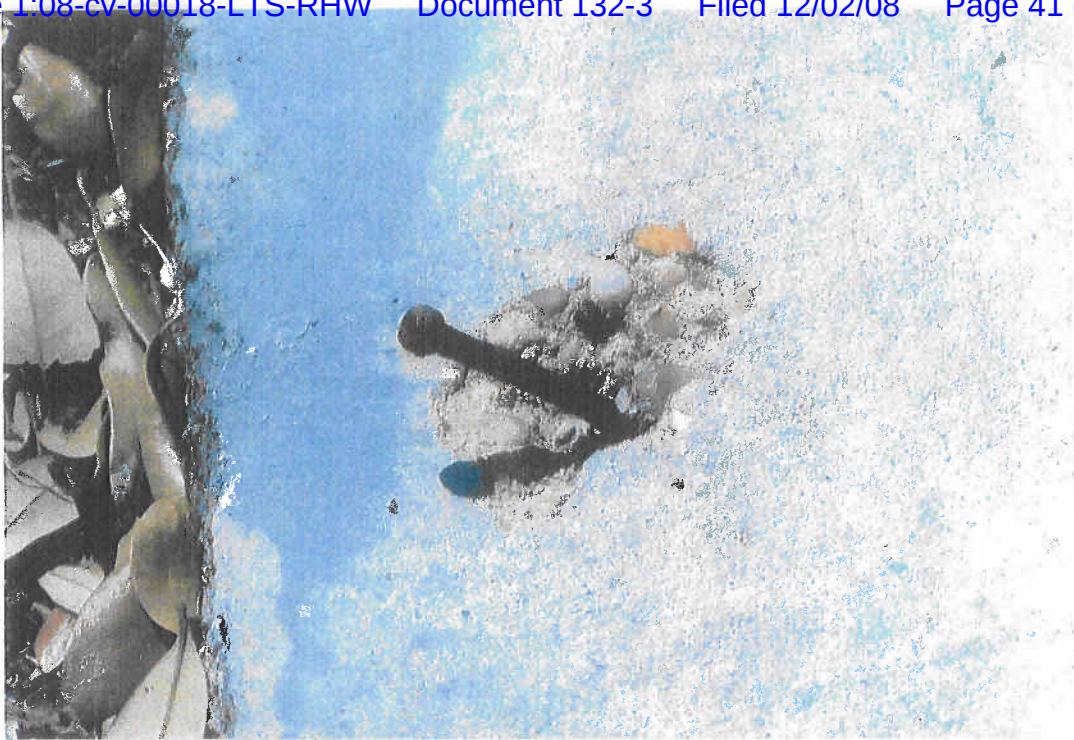
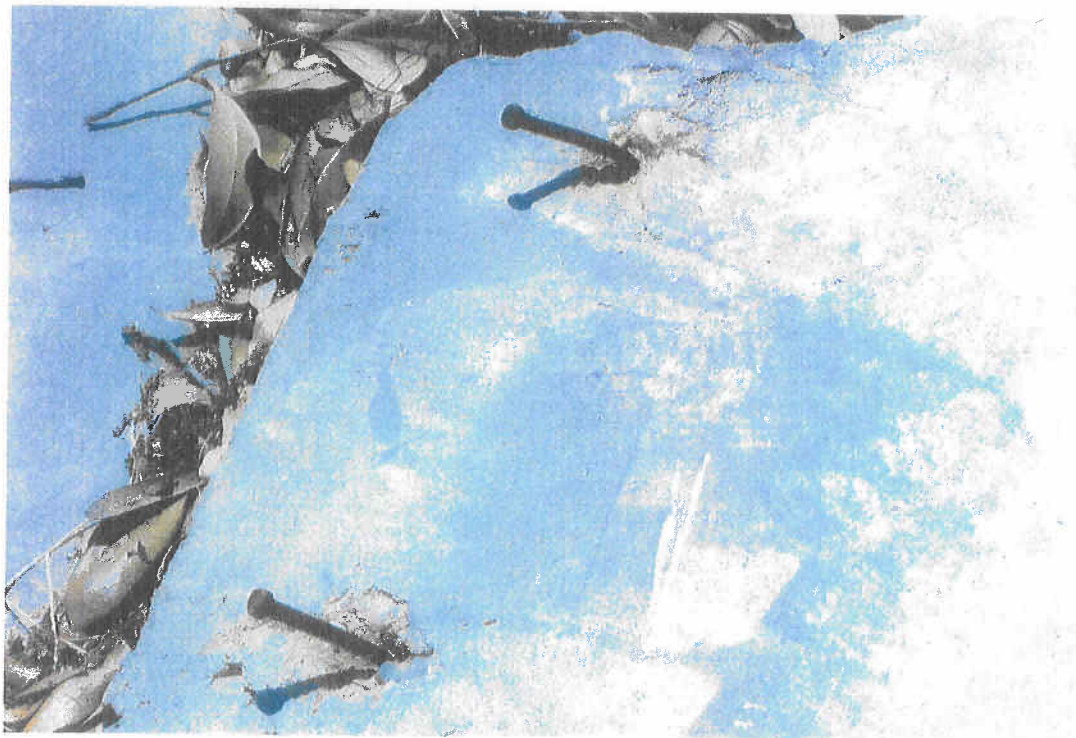
**VIEWS OF REMAINING CONCRETE NAILS ON CONCRETE SLAB
FOUNDATIONS**

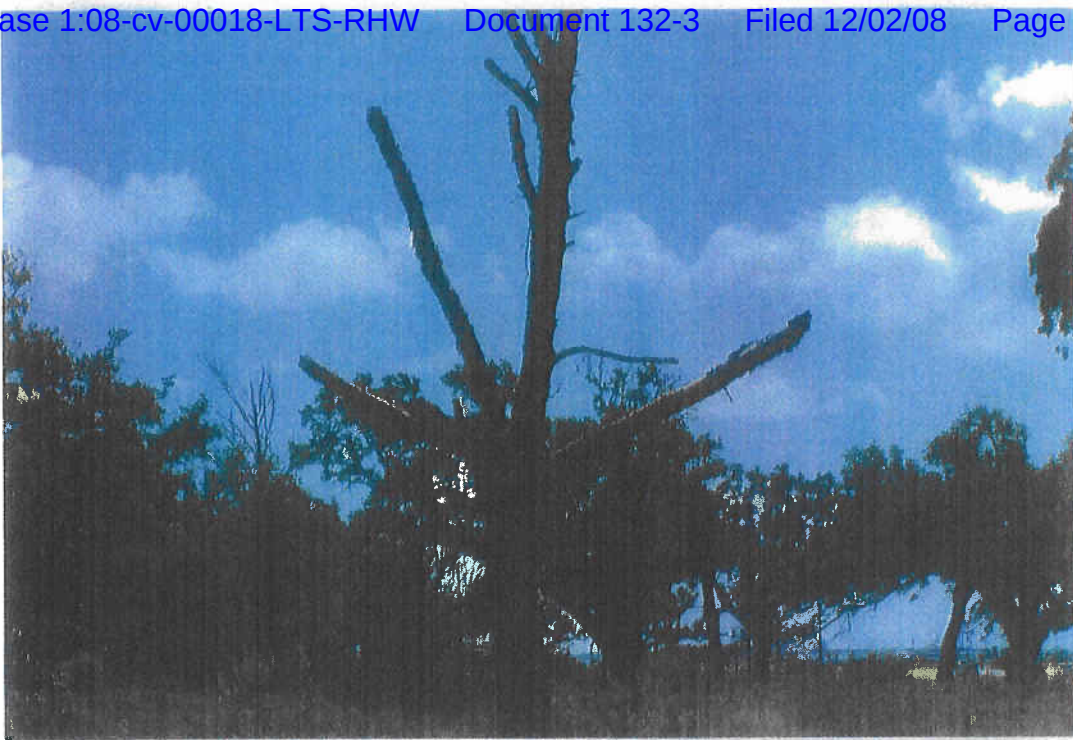
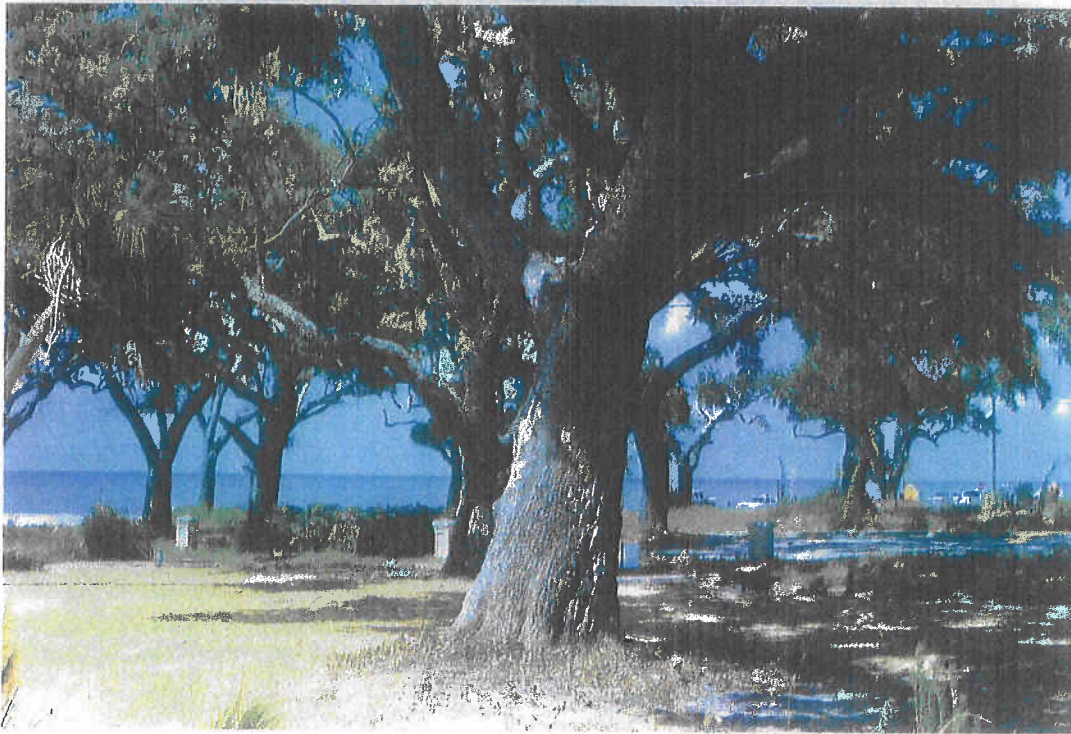
VIEWS OF REMAINING DAMAGED TREES AT PROPERTY
